#### THE VEGETATED SLOPE PROTECTION SYSTEM

**GEOWEB®**  
*slope protection system*

VEGETATED CASE STUDY SUMMARY 1

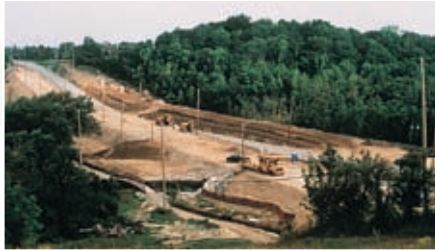
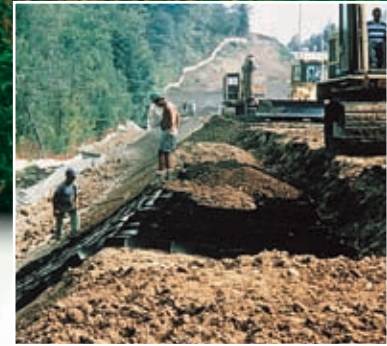
Project Photos courtesy of Armetec Limited

The Geoweb® system with tendons was installed over the embankment surface. As each embankment lift was constructed, the Geoweb sections were extended down the slope and connected with the sections in each benched area. Three tendons per section provided the structural mechanism to secure the system against sliding forces.

The slope was seeded and mass plantings were placed within the cells for immediate stabilization. Years after installation, the slopes remain vegetated, stable and performing as designed.

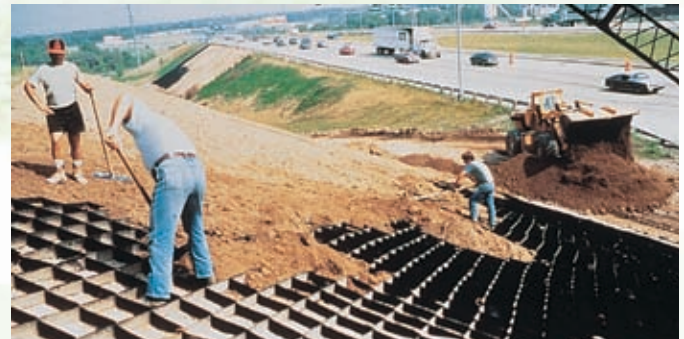
Project Photos courtesy of Meredith Brothers

The Geoweb® system was employed to stabilize the slopes on the north side of I-480. Landscape crews prepared the slopes by removing 100 mm (4 in) of soil, and finish graded the site so the Geoweb sections were flush with the adjacent terrain. After all sections were secured on the embankment, a bucket excavator filled the cells with topsoil. The following spring, small areas of the Geoweb cell walls were cut and opened in order to plant trees and shrubs. Where natural springs existed within the hillside, a clear stone infill was used to allow water drainage.

Following the installation, Northern Ohio received heavy rains through the fall, winter and spring. The Geoweb slope protection system's performance was reported as exceptional.

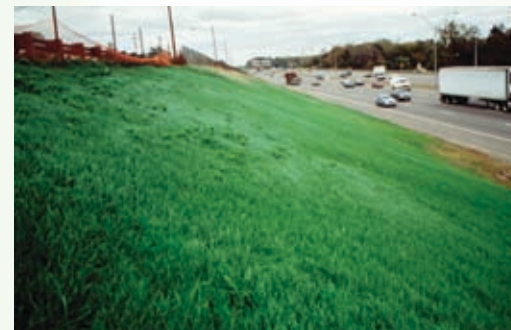
Project Photos courtesy of Sunshine Supplies, Inc.

Providing stable vegetative cover to a large slope tested the ingenuity of the project engineer and contractor during construction of a new solid waste transfer facility. The entire site was cut out of a large shale hill. The excavation left a 1h:1v slope length ranging from 21-91 m (70-300 ft) and a base length of 760 m (2500 ft) long. Budget constraints did not allow the slope angle to be reduced, leaving the unprotected shale subject to erosion problems. The comprehensive solution specified as the reinforced slope cover included the Geoweb® system.

A 4-oz non-woven geotextile followed by Geoweb sections were secured on the slope. High-strength tendons, anchored to a 3-in PVC pipe at the crest, were integrated to counteract the significant sliding forces. A high-speed conveyor truck sprayed the infill 15-18 m (50-60 ft) onto the slope as crews, suspended by harnesses, raked the

to direct and transport fill farther down the slope. After infilling, a rainstorm provided a natural hydro-tamping prior to hydro-seeding. An erosion control blanket was finally placed as a cover to prevent any surface washout before vegetation could be established.

The fully vegetated slope has remained stable and is performing to specification.

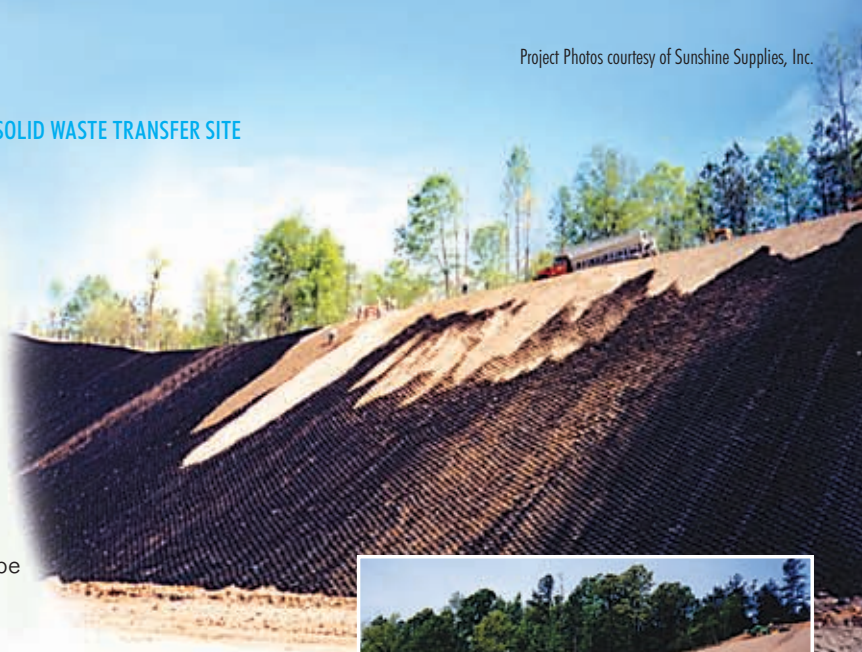
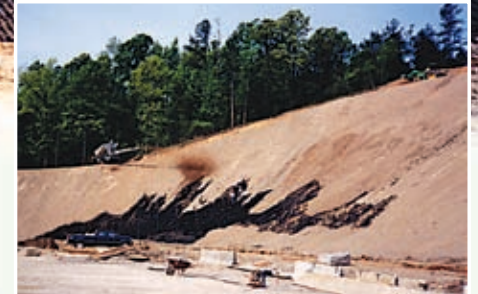
infill into the Geoweb cells. Varying lengths of corrugated polyethylene pipe was attached to the conveyor discharge

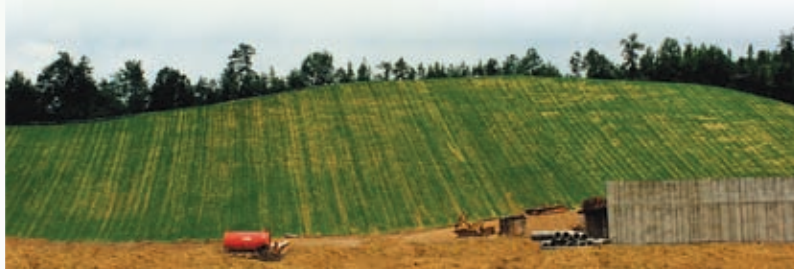
The sandy clay embankments along Route 220 were subject to severe surface sliding and loss of vegetative cover,

particularly after heavy rainfalls. The problems were most severe on embankments with steep slopes. As past attempts to stabilize the soil and control surface erosion with conventional methods had failed, the Geoweb® system was chosen to repair the 1h:1v slopes.

VDOT crews first prepared the severely eroded slopes. The upper row of Geoweb cells was placed over existing

the infill level with the top of the cells, and hydro-seeded.

The protected slopes support vegetation and have withstood years of exposure without problems. VDOT has approved the Geoweb system for use in similar slope applications throughout the state.

guardrail posts, plus staked at 0.9 m (3 ft) centers and the sections expanded down the slope. A sandy clay soil/topsoil mix was placed in the sections with a telescoping boom excavator. Crews raked

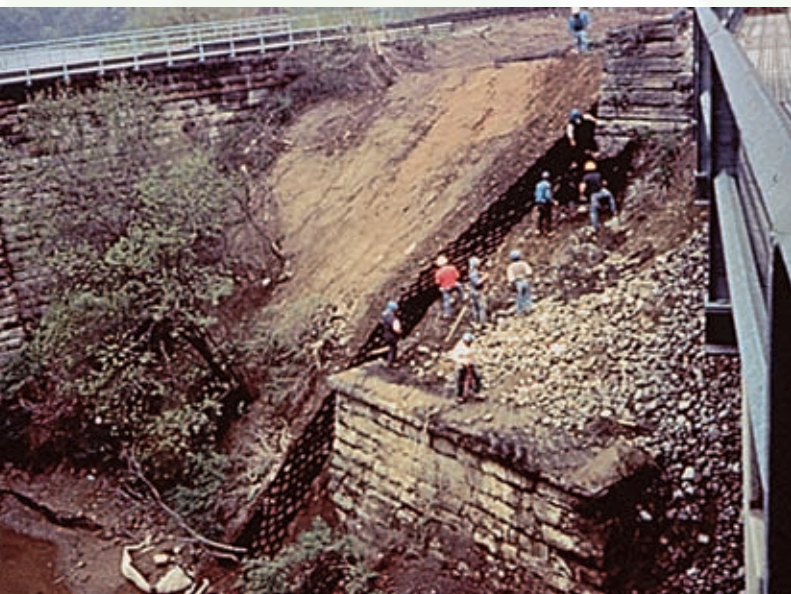
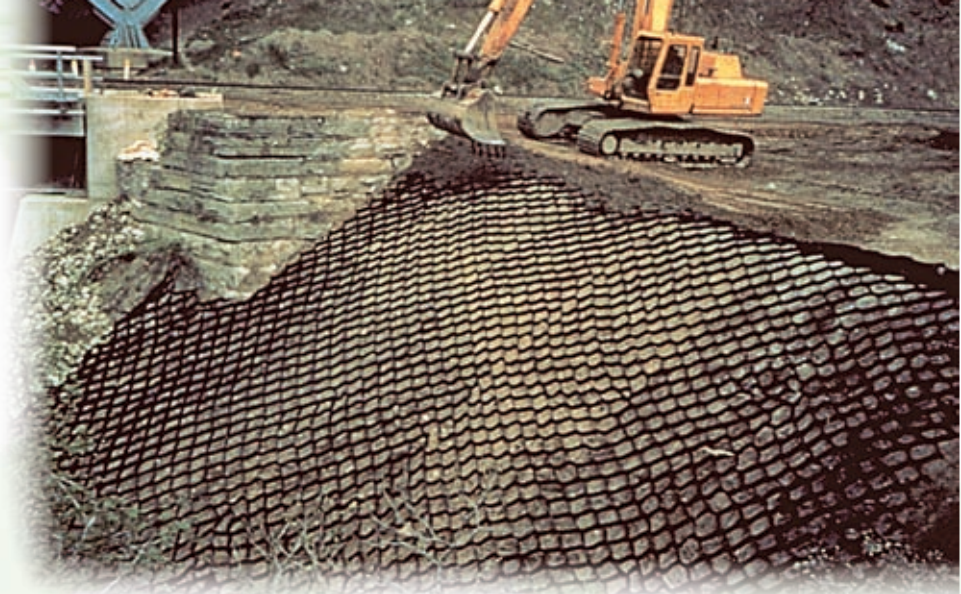
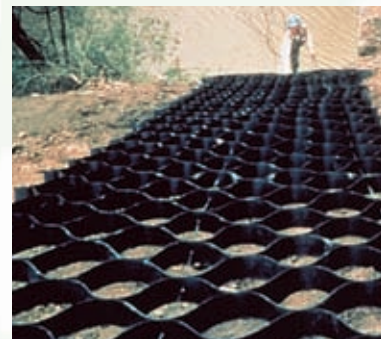
Project Photos courtesy of InterSol Engineering

The silty clay material was placed and compacted to restore the slope's original profile. The 100 mm (4 in) depth Geoweb material with three tendons per section was installed on the slope cover and anchored with stakes. The use of tendons in the design provided cost-savings by allowing the stake diameter and density to be reduced. A track backhoe with an extended bucket infilled the system with topsoil.

That fall prior to hydro-seeding, the area was exposed to 35 to 100-year rainfall – the remnants from Hurricane Opal. McCormick Rankin, the consulting engineer, reported that when exposed to those conditions, the steep slope section protected with the Geoweb system performed far better than unprotected areas.
