"Beat the Clock"

Recreating Natural Vegetation in a Hurry

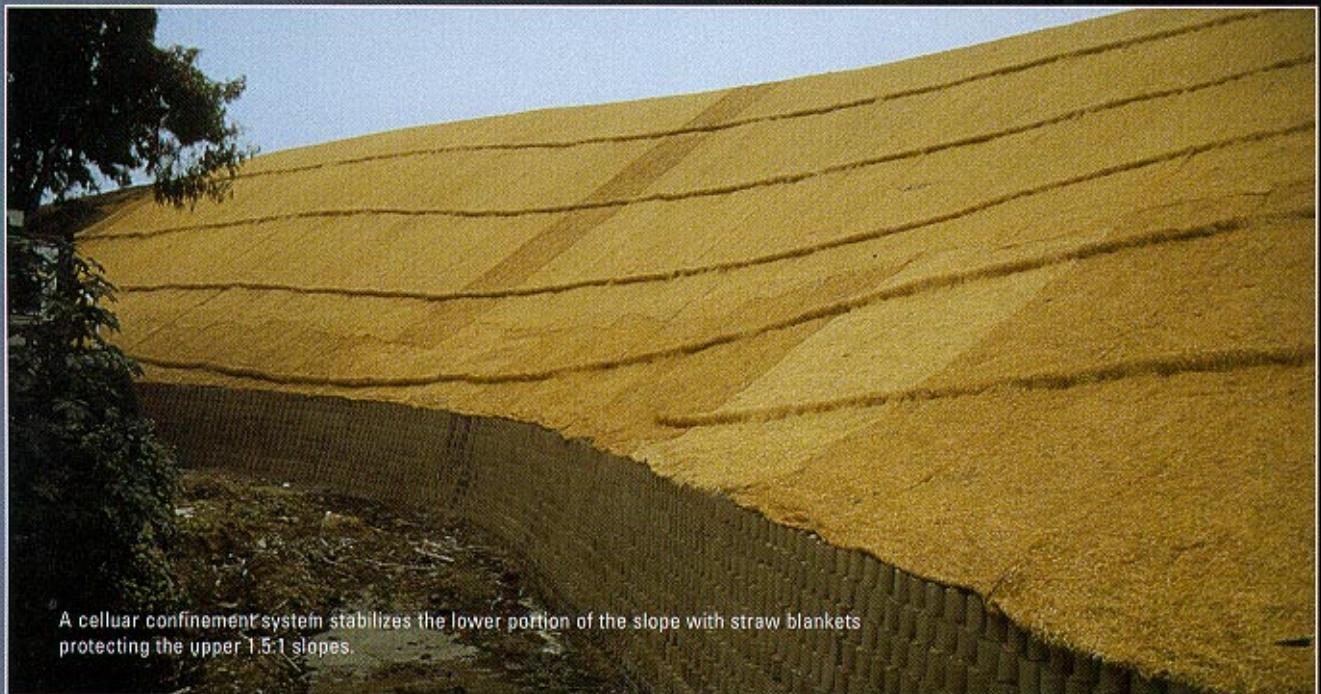
A cellular confinement system stabilizes the lower portion of the slope with straw blankets protecting the upper 1.5:1 slopes.

The solution adopted included a 2.4 m- (8 ft.-) high, vegetated gravity retaining wall constructed with a cellular confinement system. "It allowed us to recreate natural vegetation, keeping with the historical look of the slope, and it provided the needed structural strength," says Steven Musillami of Dangermond and Associates in Sacramento, CA. At the time Musillami was a landscape architect with the California Department of Parks and Recreation.

The retaining wall was built with Presto Products' Geoweb, a honeycomb-like cellular structure, 20 cm (8 in.) tall. The cells of a cellular confinement system can be filled with various granular materials to produce a uniform structural mass that resists lateral pressures and maintains structural integrity through high frictional forces between layers. One layer of the cellular system is laid atop another to form either a vertical or stepped face. In this case the width of each layer, front to back, varied from about 1.2 to 3 m (4 to 10 ft.). All cells except for the outer row were filled with drainage rock. The outer row of each tan-colored layer of cells was left exposed, filled with soil, and seeded with a native mixture.

From the top of the wall to the highway, straw wattles were placed horizontally, on the contour, about 5.5 m (18 ft.) apart on the 1.5:1 (H:V) slope to slow runoff and minimize any erosion. The slope was then seeded by hand with a native coastal sagebrush-scrub mix, the same used with the retaining wall. After seeding, the slopes and the straw wattles were protected with straw erosion control blankets. "The design and project construction wasn't that difficult," says Musillami. "The hard part was coordinating work with all the government agencies involved." The construction project was completed in August about seven months after the slope washed away "For this type of project that was a very, very short time frame," Musillami says. EC

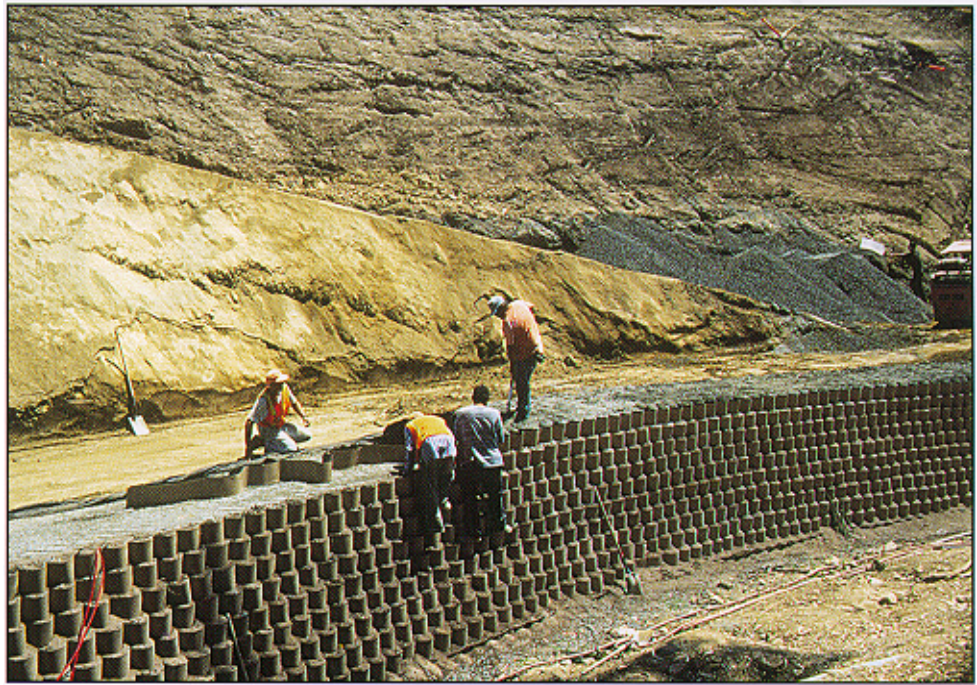
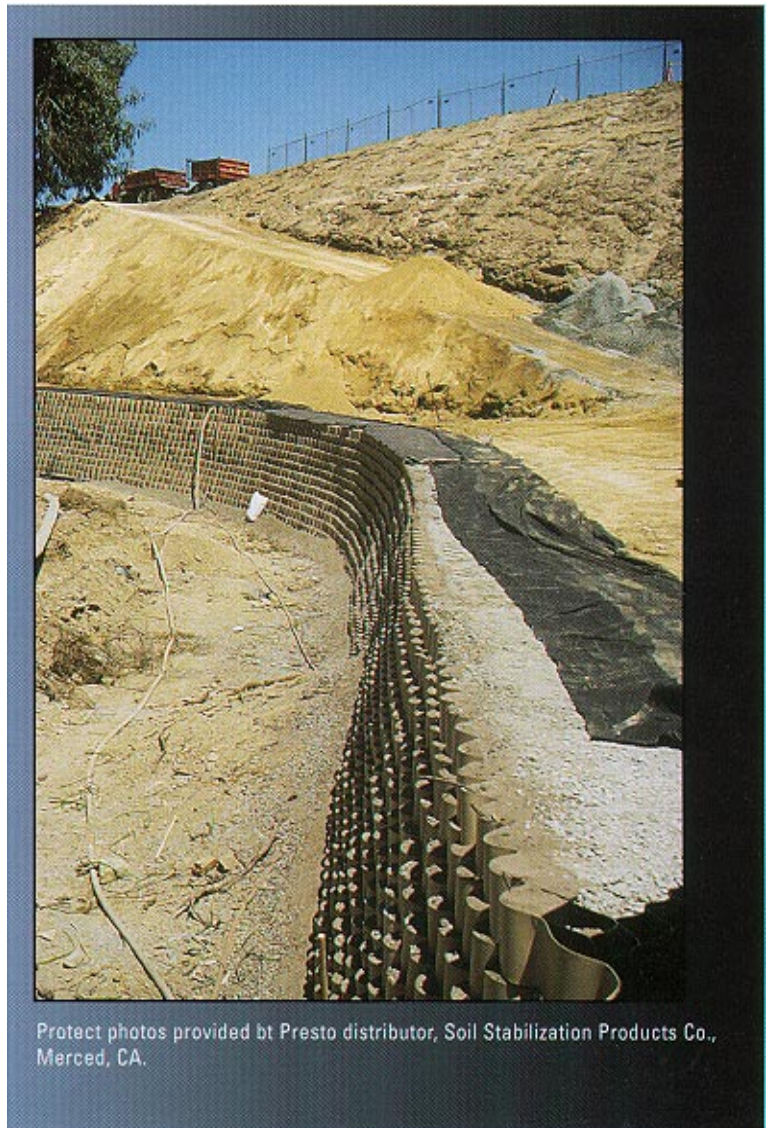
Protect photos provided by Presto distributor, Soil Stabilization Products Co., Merced, CA.
