#### THE VEGETATED EARTH RETENTION SYSTEM

**GEOWEB®**  
*earth retention system*

CASE STUDY SUMMARY 1

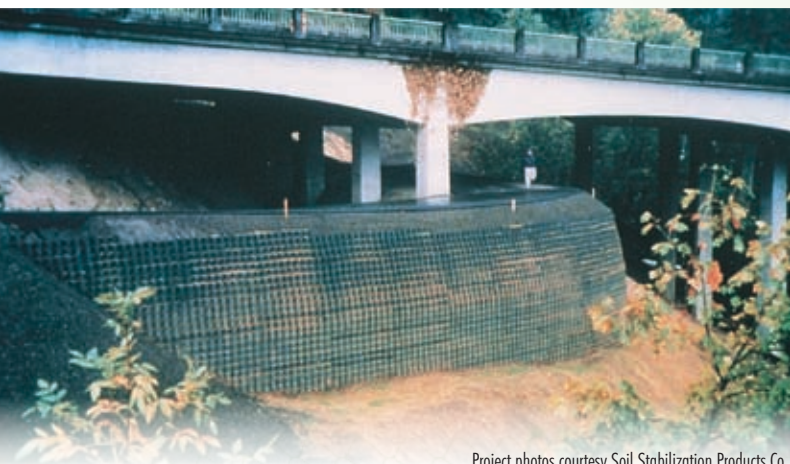
Project photos courtesy Soil Stabilization Products Co.

structures were necessary to keep the newly steepened side slopes in place. A vegetated fascia was desired to blend naturally with an environment that provides spectacular views of the river and Cascades. A geocomposite solution combining the Geoweb® system with high-strength woven geotextile soil reinforcement was chosen.

Six wall structures were required, one over 5 m (16 ft) in height. Green outer face panels blend naturally with the surrounding landscape. Perforated interior cell walls allowed drainage of the infill material. To establish vegetative cover quickly, ODOT hydroseeded the completed walls.

After installation, a substantial natural spring was discovered behind one wall. Lower outer fascia panels were simply removed, exposing the perforated interior cell walls and allowing drainage without damage to the wall structure. A drainage system was later installed to reduce the potential for hydrostatic pressure buildup.

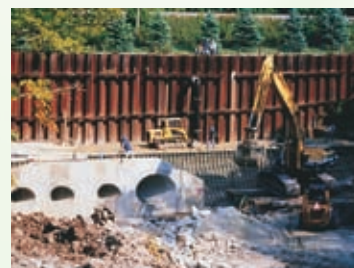
Using granular soil and geogrid layers, a reinforced earth embankment was built with the Geoweb® system fascia and a front face batter of 0.75h:1v.

a green fascia panel and perforated interior cells to improve drainage and increase frictional interlock between the cells and the infill. Biaxial geogrid was sandwiched between the cellular layers every fourth course as a reinforcement layer. A trackhoe and clamshell bucket were

The finished structure included a four-pipe culvert to increase stormwater flow capacity through the embankment. The wall measured 20 m (65 ft) wide at the base, 56 m (185 ft) wide at the top with 381 face m<sup>2</sup> (4,100 face ft<sup>2</sup>). The finished embankment was hydroseeded with a mixture of annual rye cover, prairie grasses and flowers. All involved parties agreed that this vegetated geocomposite wall system was a success.

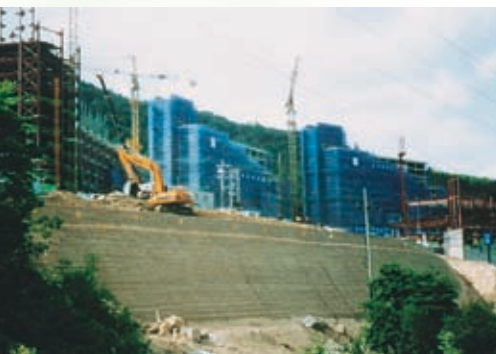
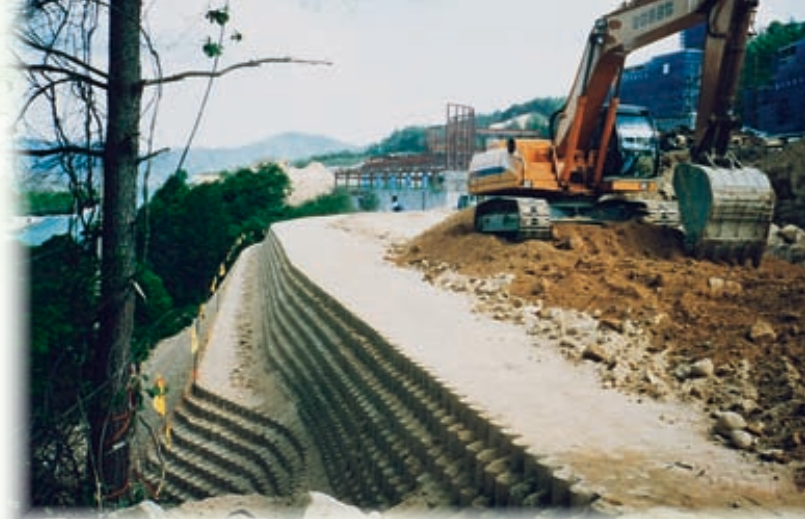
Project photos courtesy E & S Engineering

The retaining wall structures were formed by layering tan-faced Geoweb sections. For soil reinforcement, geogrid or high-strength woven geotextile layers were placed at required design intervals. The largest of the structures measures 200 m (650 ft) in length, with heights varying from 6-14 m (20-46 ft). Slopes range from 1h:8v to 1h:2.5v for all walls.

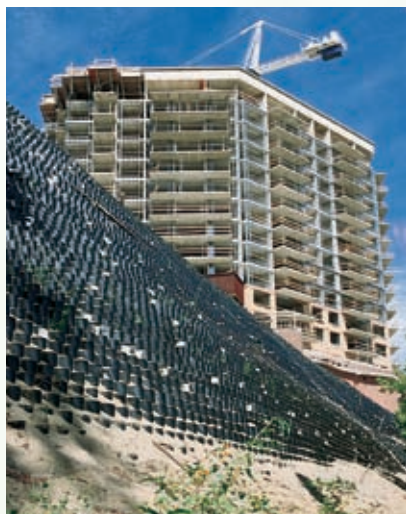
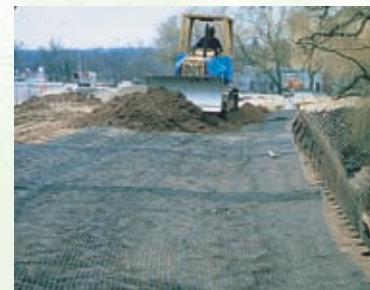
The site was prepared and Geoweb sections were placed, infilled and compacted. Subsequent layers were placed with a 25 mm (1 in) set-back until the wall height was achieved. At required design intervals, a geogrid or woven geotextile soil reinforcement layer was placed.

The completed geocomposite embankment totalled 238 m (780 ft) long and 11 m (36 ft) high, with a total wall surface of 1,400 face m<sup>2</sup> (15,000 ft<sup>2</sup>). Wall face batter varied from 1h:2v to 1h:8v. Even after years of exposure to a northern climate, the Geoweb system has performed successfully.

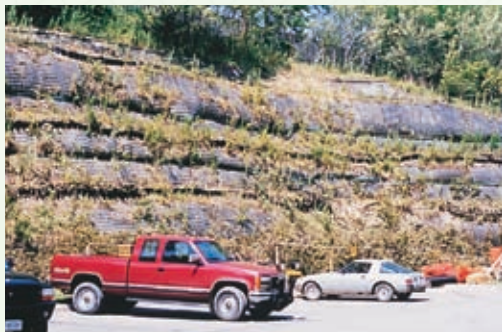
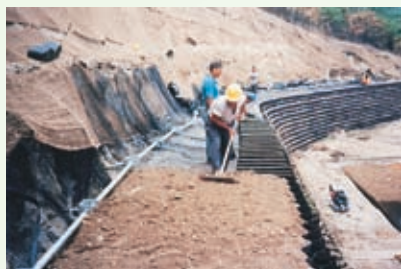
The original 2h:1v slope was excavated to a near vertical cut 10 m (33 ft) high. The slope cut was made with three terraces 2 m (6.5 ft)

wide that were vegetated for aesthetic appeal. During rehabilitation, the geosynthetic facing and all vegetation were removed, leaving the soil-nail system intact. The reconstruction utilized the existing soil nails, replacing the geosynthetic facia with the layered Geoweb system. The new 9-m (30-ft) high wall system permitted drainage through the structure's face while controlling potential soil movement. At the appropriate lifts, Geoweb sections were attached to the soil nails using a polyester geogrid, steel pipes and special soil nail heads.

In total, 460 m<sup>2</sup> (5,000 ft<sup>2</sup>) of wall face was reconstructed in three wall lifts varying in height from 2-9 m (6-30 ft). Groundcover plantings were placed in the open front facia cells and a variety of small shrubs were planted on the terraces. The developer and condominium owners are pleased with the natural look and stability of the repaired wall.
