## HAWAIIAN LANDSLIDE REPAIR UTILIZES MSE WALL SOLUTION

## Geocells Reinforced with Geogrids is the Winning Solution for Repairing Landslides in Hawaii

### ABSTRACT

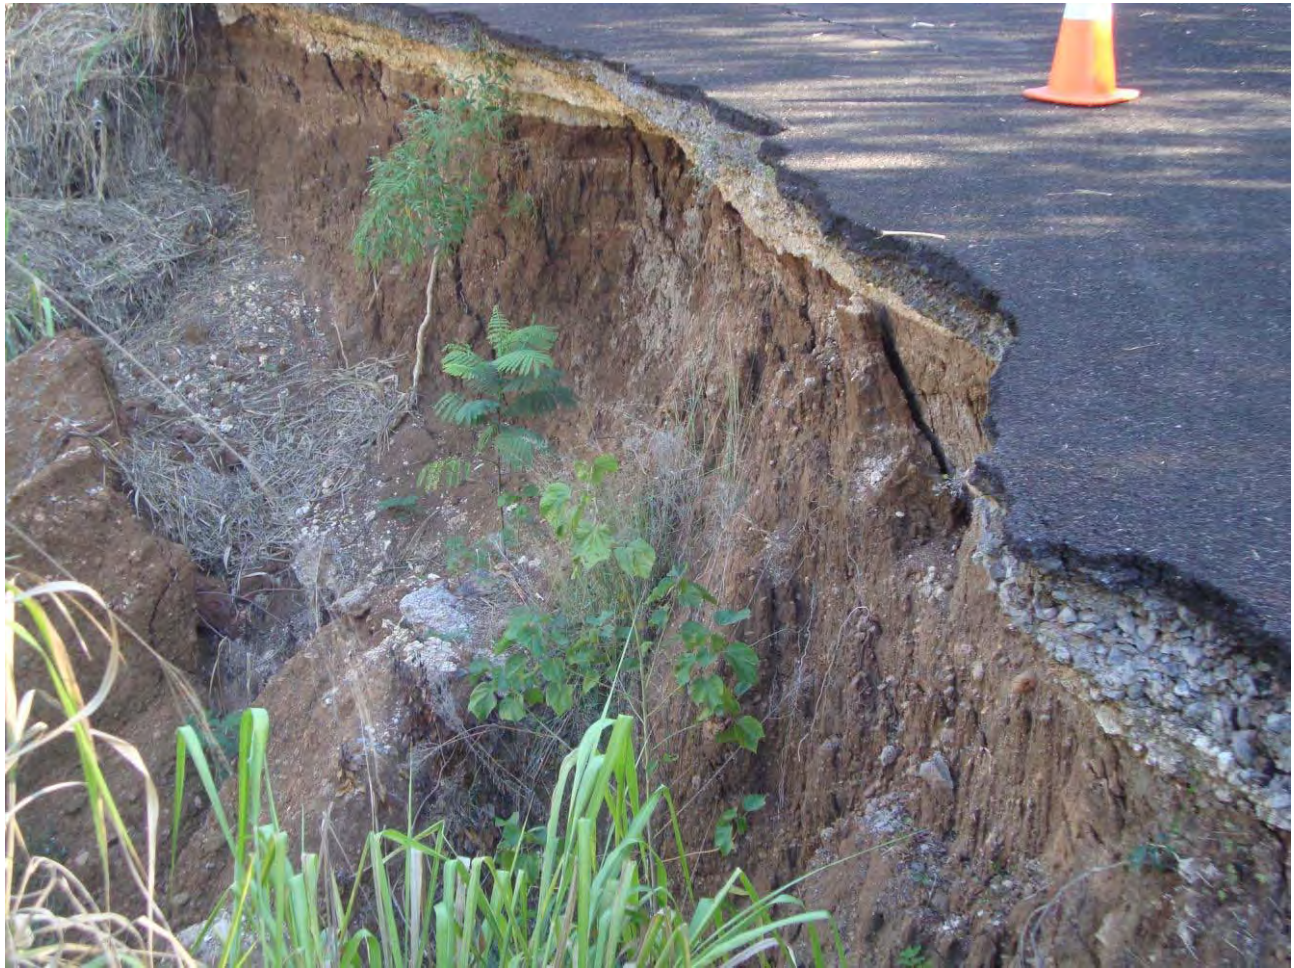
The landslides appear to have been debris avalanches that developed into debris flows (Turner and Schuster, 1996). The failures occurred in road fill, existing colluvium on the slopes, and erosion into the native soils. The primary cause of the damage was due to uncontrolled surface water runoff causing severe erosion and hydraulic excavation. Each of the landslides were located where surface water flowed over the side of the road causing severe erosion in the embankment fill. The landslide scarps at all six sites were similar. The vertical scarps were 1.5 meters (m) to 3.7 m deep directly below the road. Hydraulic excavation had created steep gullies that drained to the main ravine. The bottoms of the gullies were 6 m to 12 m below the road and had accumulations of colluvium and slide debris within them. Photograph 1 shows the landslide scarp at Site 4.

Photograph 1. Landscape Scarp at Site 4.

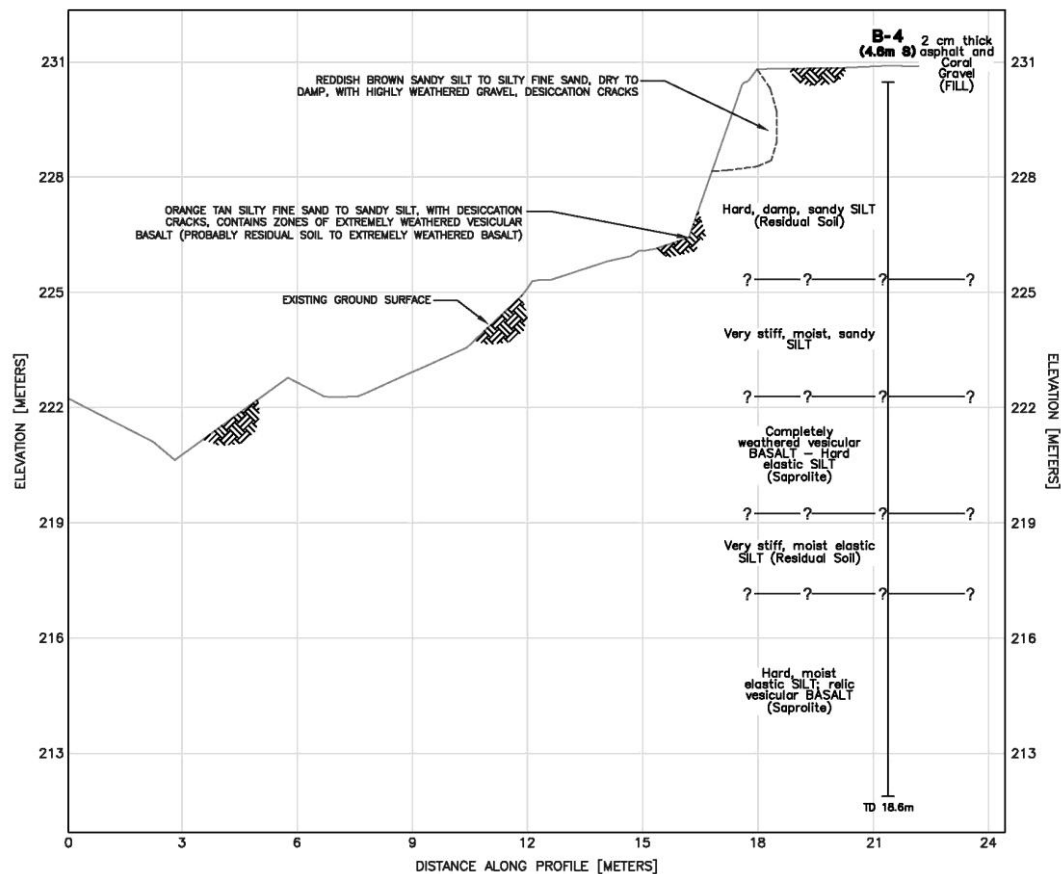
The borings drilled at each site and the soils observed in the scarps documented road fill, residual soils, and saprolite derived from vesicular basalt. Geotechnical laboratory tests revealed that the residual soils and saprolite are generally high plasticity silt with moisture contents near their plastic limit. The laboratory strength tests results showed large variations, at least partially due to the difficulty of collecting and testing very stiff soils. Based on observations of exposed soils, drilling and sampling results, and laboratory testing, the soils possess high shear strengths. Figure 1 is a geologic cross-section from Site 4 that illustrates AMEC's stratigraphic interpretations, which was similar to all six sites.

Figure1. Site 4 Geologic Cross-Section.

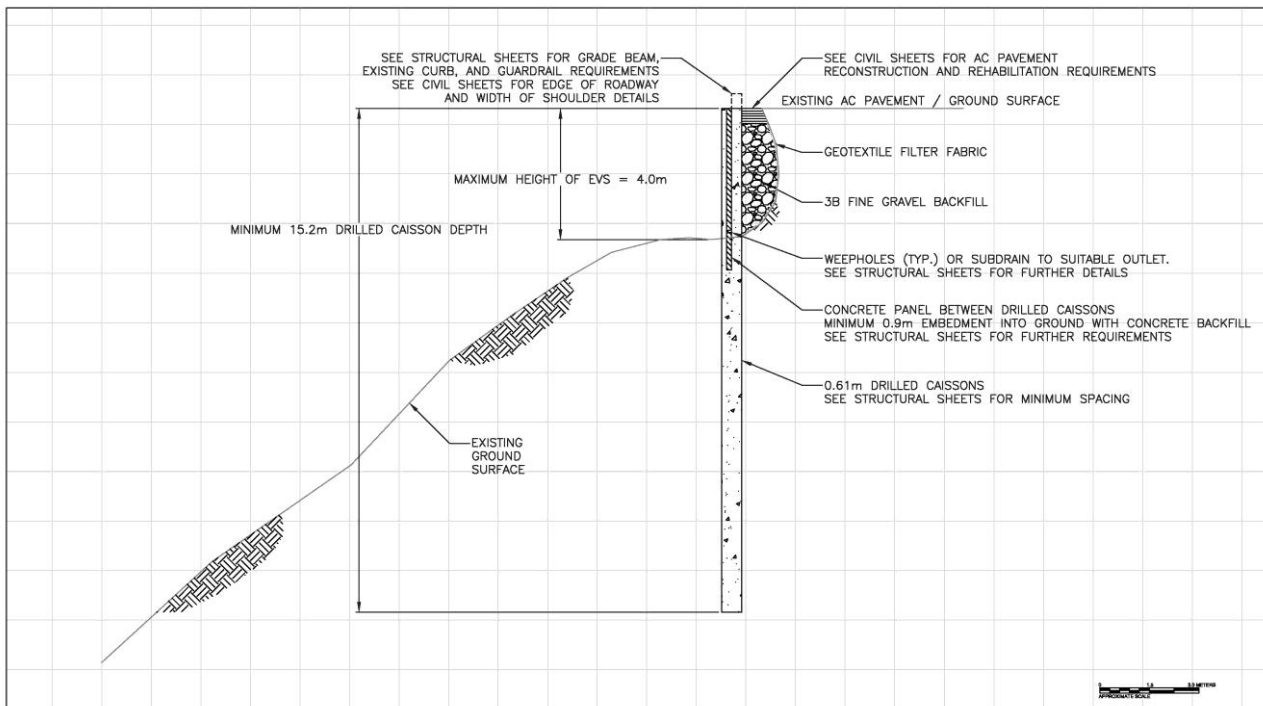
Three conceptual retaining wall options were included in the RFP for restoring the roads. The first concept used a cast-in-place concrete wall supported with micropiles; the second option used micropiles, a shotcrete wall face, and a cast-in-place concrete drive slab; and the third option used drilled shafts, steel H-beams as soldier piles, and pre-cast concrete panels for lagging (Figure 2).

Figure 2. Conceptual Walls.

The selected design-build team determined that pile structures were too expensive and too difficult to construct safely near the edge of the landslide scarps. Access would have been difficult for the large equipment needed for the steel pile and concrete wall concepts. The team decided that mechanically stabilized earth (MSE) walls could be constructed less expensively, quicker, and more safely. Rock slopes and reinforced soil slopes were also considered; however, the toe of the slopes would have extended beyond allowable construction limits into wetland areas for most of the sites. A rock slope was used to restore Site 6, the smallest of the landslides, with minimal site impacts. Gabion basket gravity walls were considered, but the baskets were not readily available on the island and they would have been susceptible to corrosion in the highly humid tropical environment. Stacked geocell facing with geogrid reinforcing layers were selected for their design advantages, constructability, and availability on the island for five areas.

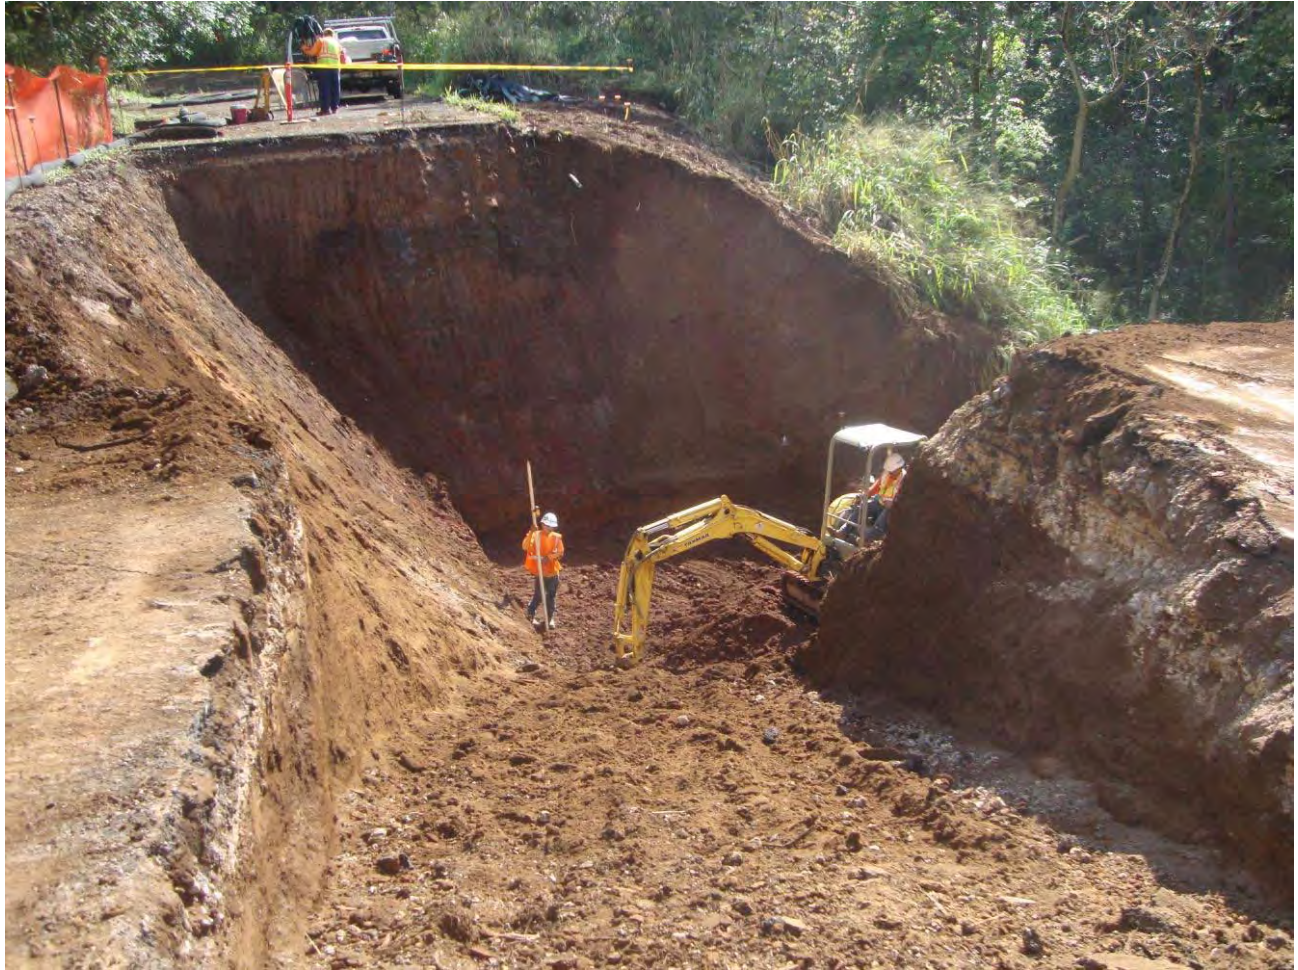
The proposed walls were located close to the previous edge of the road shoulder due to the construction limits and access limitations. Furthermore, due to the depth of the landslides, a large amount of temporary excavation was necessary to access the base of the wall, allow room for the geogrid reinforcements and create a safe slope for workers (Photograph 2).

Photograph 2. Site 1 Excavation, Total Depth of 6.1 meters.

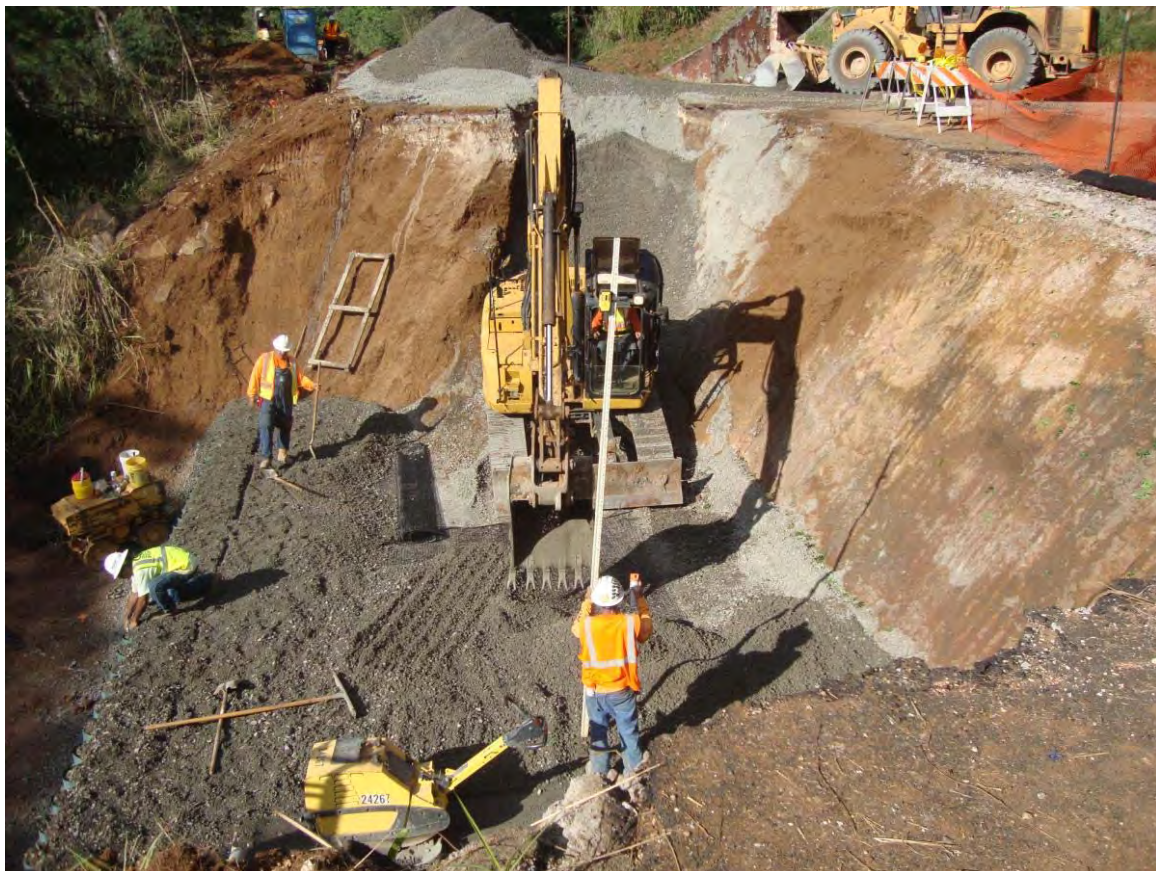
The geocells consisted of polyethylene, stabilized for ultraviolet light and corrosion, forming cells that were 27 cm long by 33 cm wide by 15 cm high when expanded. The geocells were delivered in sections 0.80 m wide by 2.6 m long. Each course of geocells were stacked with a 2.5 cm setback from the course below, to achieve a batter of 1H:6V. The geogrids consisted of polyester multifilament yarns woven in tension and finished with a PVC coating and had a long-term design strength (LTDS) of 45 kN/m. The LTDS is determined by reducing the ultimate tensile strength to account for potential material degradation. Both the geocell infill and the wall backfill material was a crushed and screened gravelly sand, meeting the HDOT 703.18 Filter Material specification (2005), which had a maximum grain size of 4 cm and less than 5 percent fines (Photograph 3).

Photograph 3.Site 1 Backfilling.

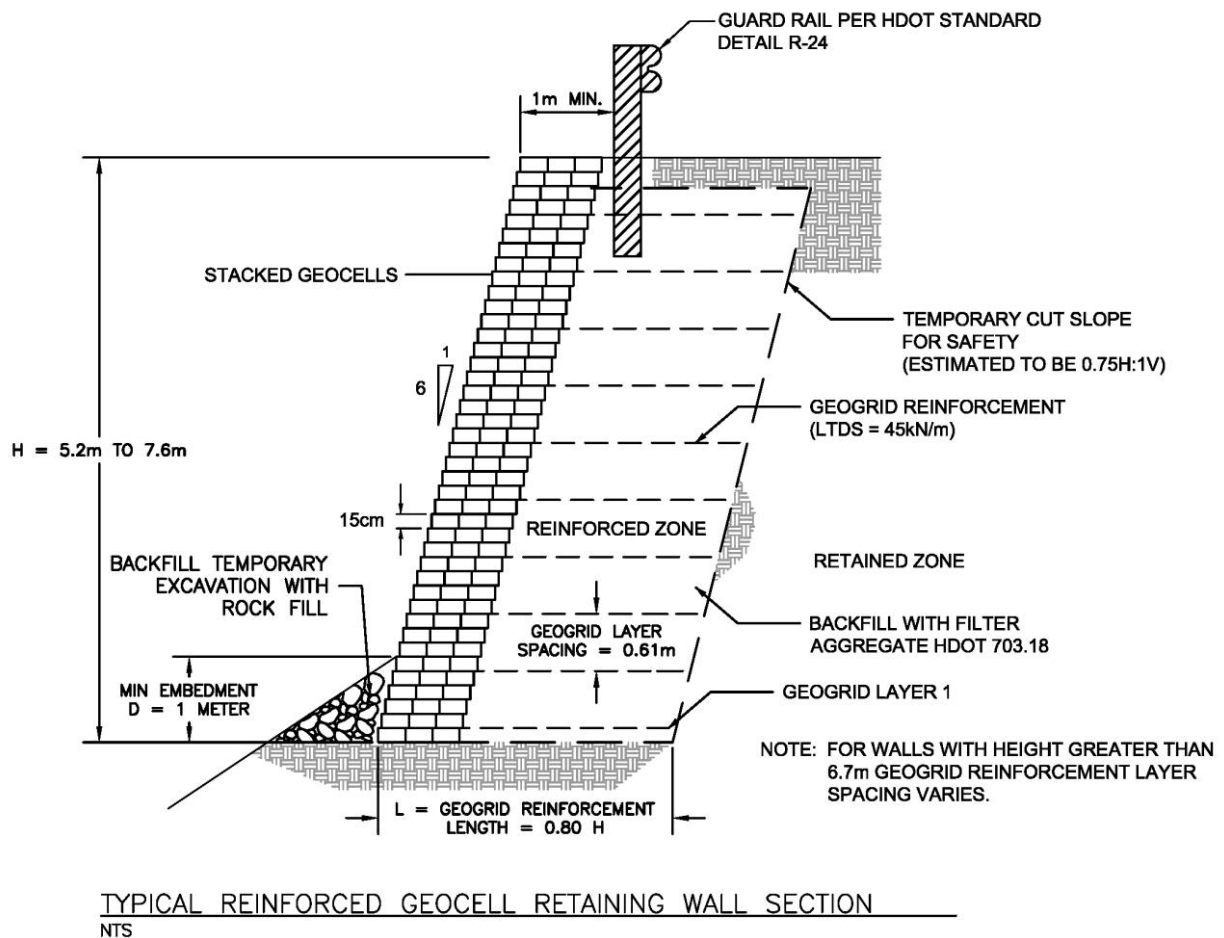
The walls were embedded a minimum of 1 m into the intact soils. This embedment is deeper than typical installations due to the falling foreslope and desire to ensure global stability. The typical design cross-section (Figure 3) displays the wall components.

Figure 3. Design Cross-Section.

Geogrid lengths were approximately 80 percent of the total wall height and spaced every 0.61 m (four stacked geocells), except for walls greater than 6 m tall, in which case the geogrid spacing was less for the lower portion of the wall.

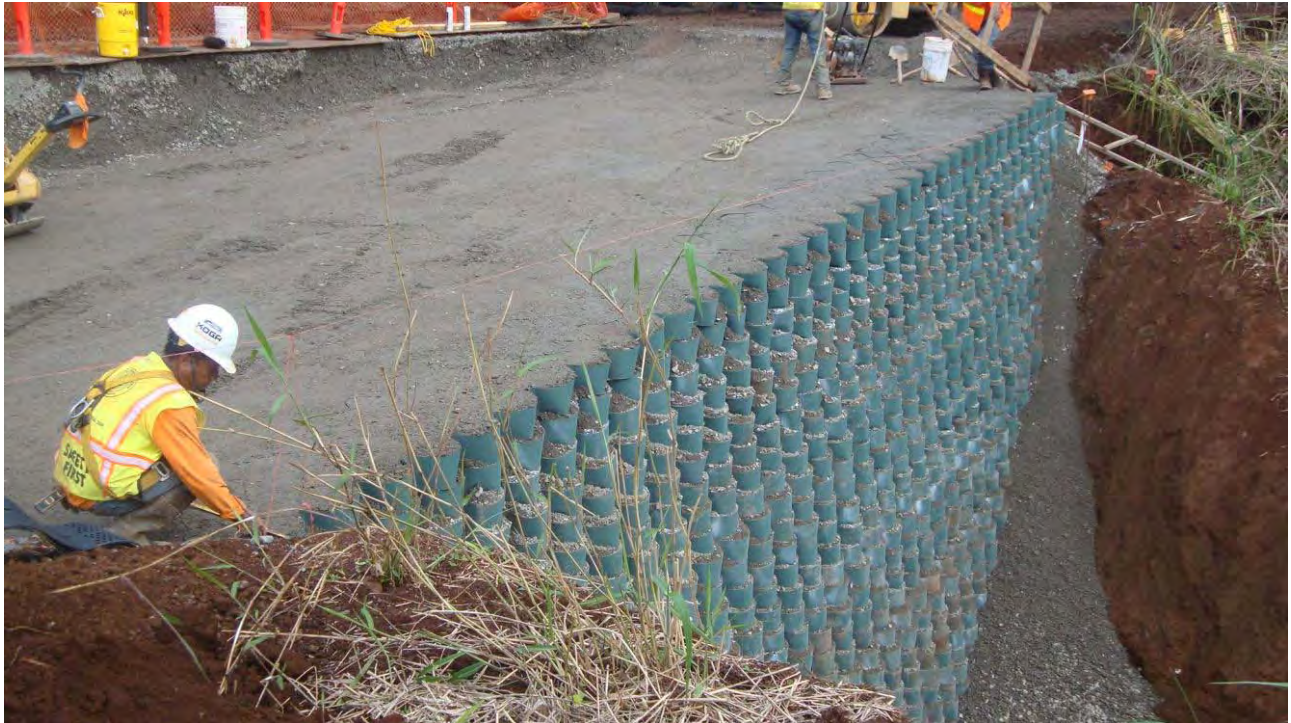
- The outer edge of the geocells will eventually become vegetated blending the wall into the tropical environment. In addition, the green colored geocells initially blended in with the lush vegetation of the ravine, even without becoming vegetated (Photograph 4).

Photograph 4. Site 4 Near the End of Construction.
