BYPASS ROAD CONSTRUCTED OF

Sand, Coral, and a Cellular System

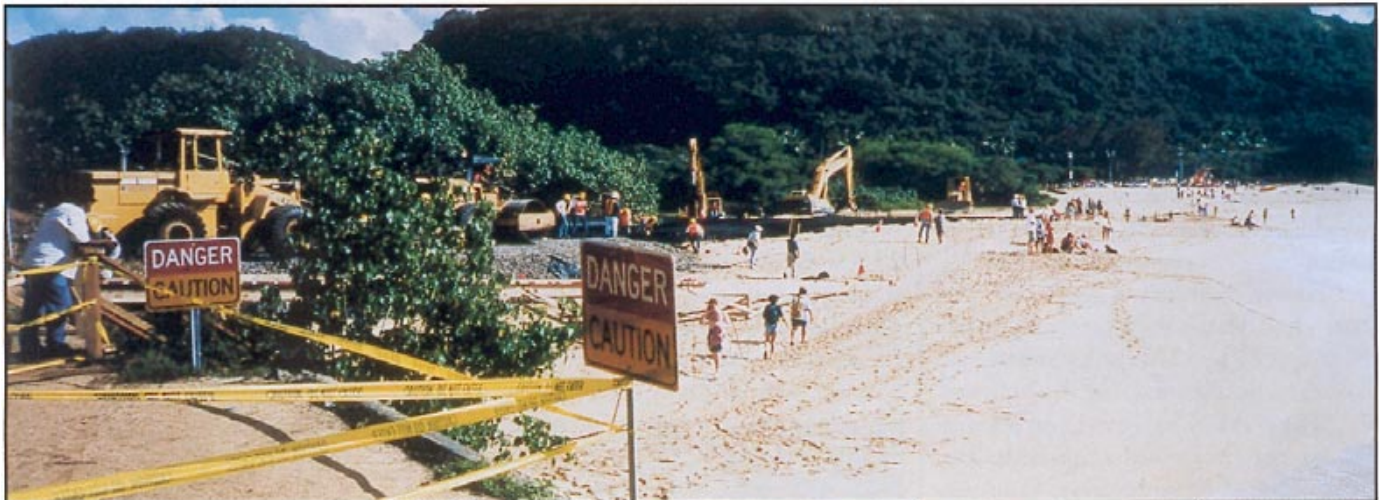
Panoramic view of the bypass road construction.

Material sections 8 ft by 20 ft are placed three across to create the 24-ft wide, 1,000-ft long roadway.

Cellular confinement was originally developed by Presto and the U.S. Army Corps of Engineers as a means of constructing rubber-tired military vehicle access roads over beaches. The three-dimensional polyethylene, honeycomb-like structure confines and strengthens cohesionless materials in its cells, preventing shear failure and lateral movement of the infill material. The system produces a stiff base with high flexural strength, acting like a semi-rigid slab by distributing loads laterally and reducing subgrade contact pressures.

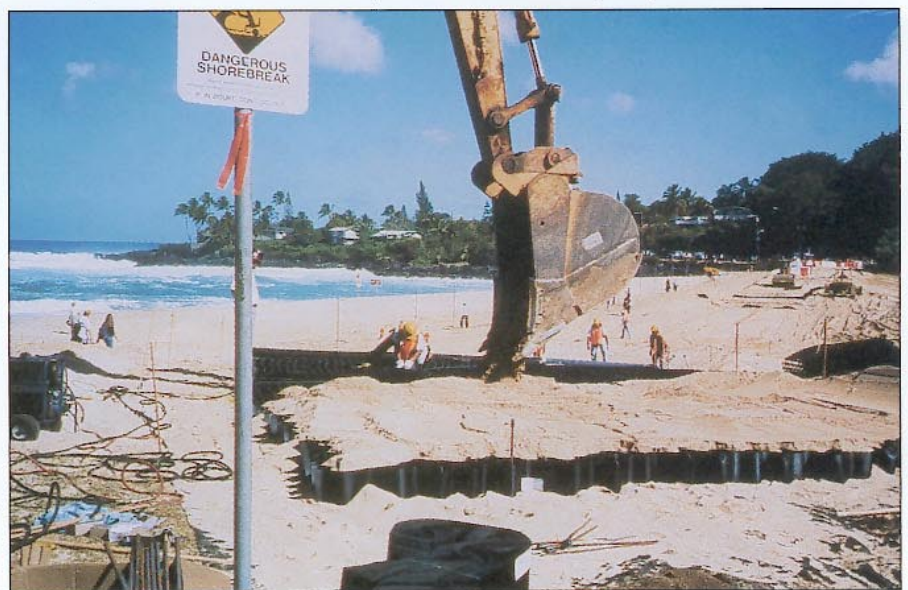
Native beach sand is placed in the expanded cellular confinement sections with a backhoe.

The bypass road was constructed by placing a layer of geotextile directly onto the sand. The first course of eight-in. deep Geoweb sections was placed and infilled with the surrounding beach sand and compacted. A second course of cellular material was placed repeating the same procedure. The top three in. consisted of imported crushed coral that was placed on top of the two courses, saturated, and compacted. The eight-ft by 20-ft sections of material were placed three across to create the roadway. Two polyethylene drainage pipes were laid under the roadway to allow water from mountain runoff to pass under the road. Water-filled barriers were placed on both sides of the roadway to help delineate the two traffic lanes, protect the cells nearest the edges, and

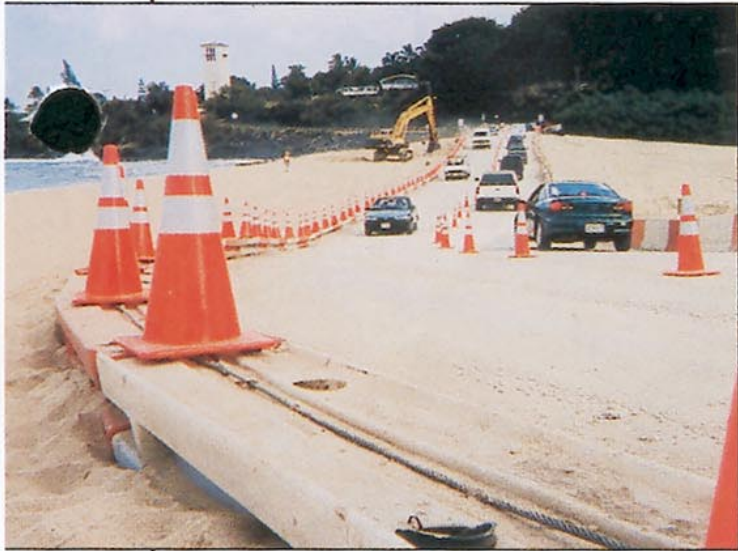
The completed bypass road, topped with a compacted crushed coral, accepts traffic.
