# Geocell Shoreline Cover Supports Aquatic Plantings Over Impervious Liner

by Lee Bull, Greg Kramer and Patricia Stelter

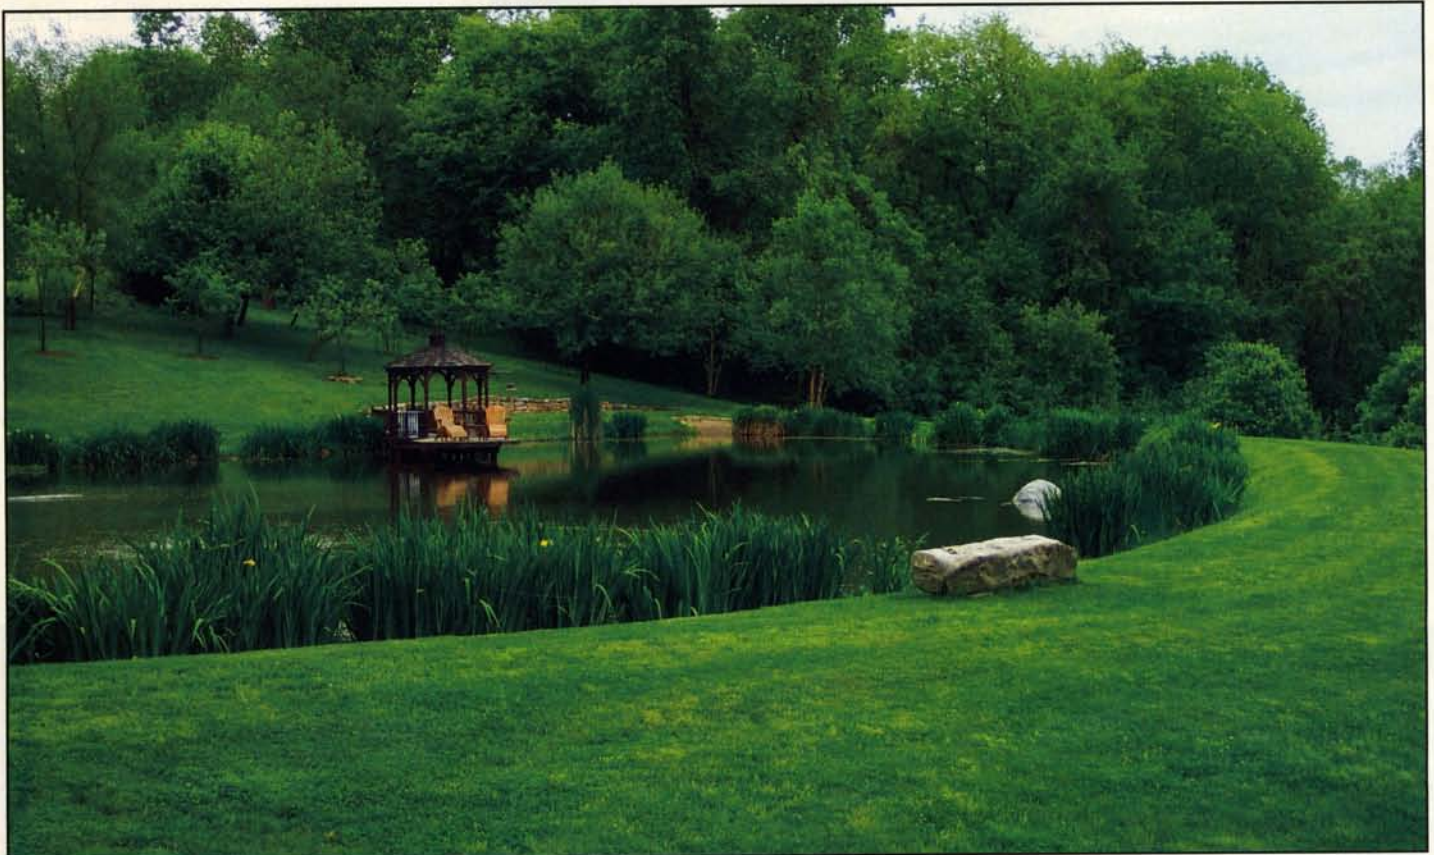
The fully stabilized and vegetated shoreline hosts a variety of aquatic plantings.

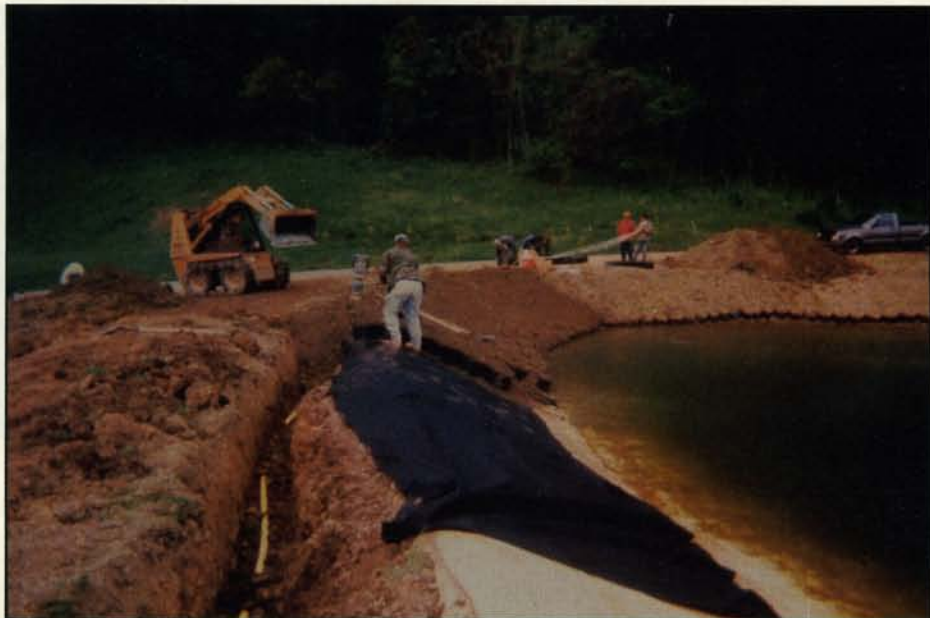
**Geoweb sections are secured over the geotextile and geomembrane layers with tendons tied to a deadman anchor.**

Tendons threaded through the geocell sections would be secured to the dead man anchor, allowing the sections to be securely suspended over the liner without the use of typical array of stake anchors which would puncture the liner.

At the crest of the embankment, the tendons were tied to the dead man anchor. To accommodate the pond’s continuous radius, two to three sections were placed in one direction and two to three sections in the other direction leaving an occasional small wedge-shaped gap in between. The gap was filled in with a cut section to fit the irregular shape.

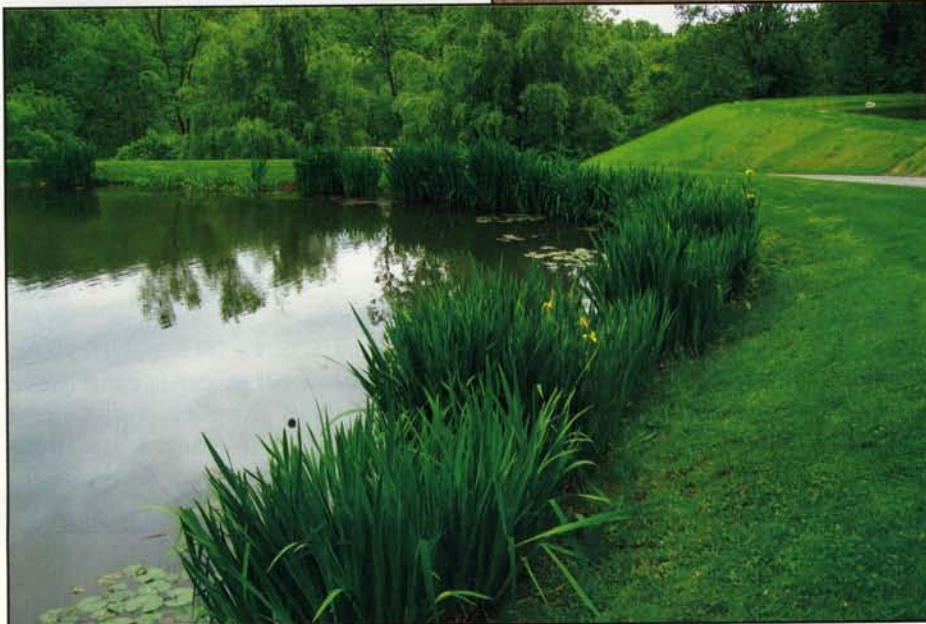
**Topsoil within the geocell sections creates a planting medium for the desired water plants.**

bobcat to cover the anchor trench and to infill the geocell sections. Topsoil was then raked flush to the top of the cells.
