# GEOWEB®

## STREAMBANK RESTORATION

### BROOKTREE CREEK

Citrus Heights, California

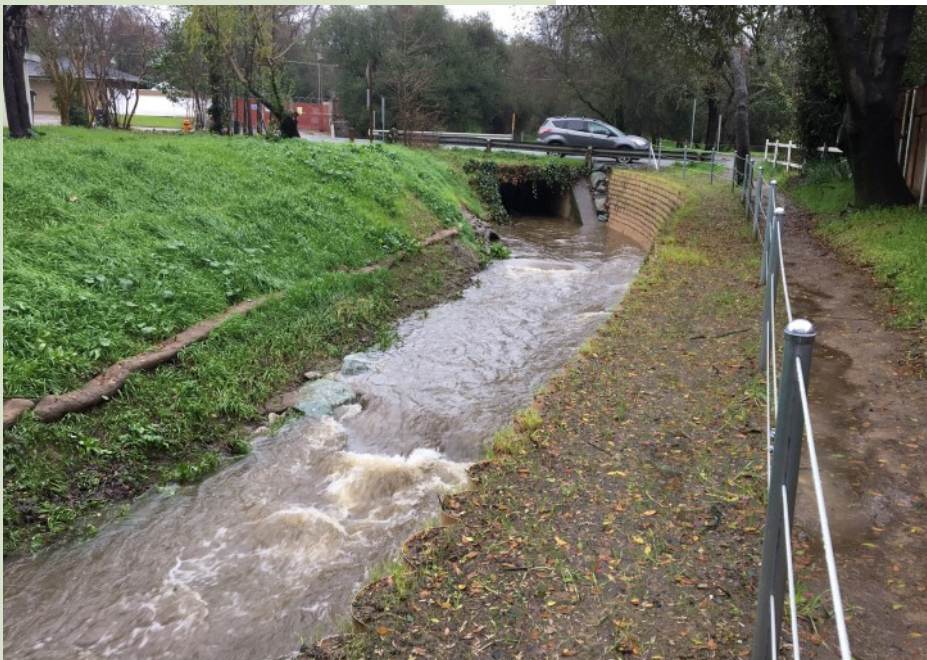
Once the project was designed, the construction started by removing the oak trees with exposed roots that could not be saved in the excavation of the new channel. Platipus percussion anchors were driven into the bank and tied off to a deadman anchoring pipe. Kevlar tendons were attached to the GEOWEB panels and tied off to the deadman anchor to secure the wall. Mirafi 3XT geogrid was installed every 4th lift to provide the support required for this installation. The GEOWEB footing courses were filled with concrete to provide a non-erodible base. Upper GEOWEB courses were filled with topsoil in the front exposed fascia cells to provide a growing media for vegetation, and then covered with Enkamat 7010 Turf Reinforcement Mat to prevent infill loss.
