NATURAL SOLUTIONS

VEGETATED GEOCELLULAR CHANNELS SHORE UP EMBANKMENTS,
MITIGATE FLOODING CONCERNS.

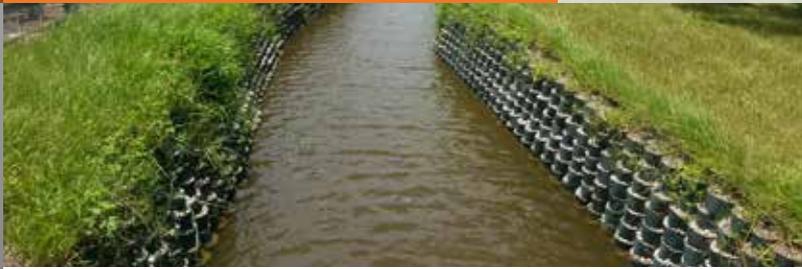
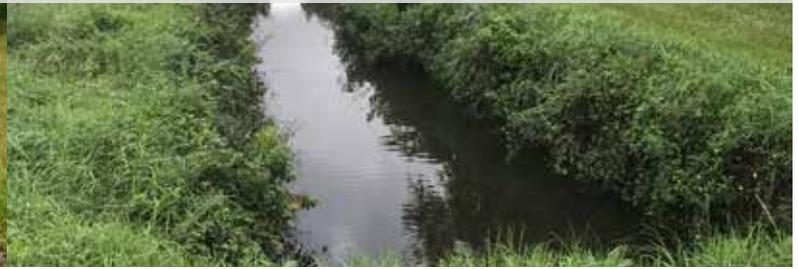
Chronic drainage issues along a Florida roadway were alleviated by incorporating naturally vegetated GEOWEB channels to prevent erosion (left). Four years after installation, vegetation in the channel is healthy and dense (right).

Chronic drainage issues along a Florida roadway were alleviated by incorporating naturally vegetated GEOWEB channels to prevent erosion, allow for higher stormwater volume, and reduce potential for flooding.

A newly planned channel design consisted of box culverts and open areas to allow for more volume to help alleviate the flooding potential. The GEOWEB channel system was selected to meet the needs for both erosion protection and natural aesthetics.

Four years after installation, the vegetation in the channel is healthy and dense — protecting the channel side slopes from erosion that previously limited stormwater volume and contributed to flooding, while stabilizing the desired natural vegetation. With the drainage project completed, flooding problems have been eliminated.

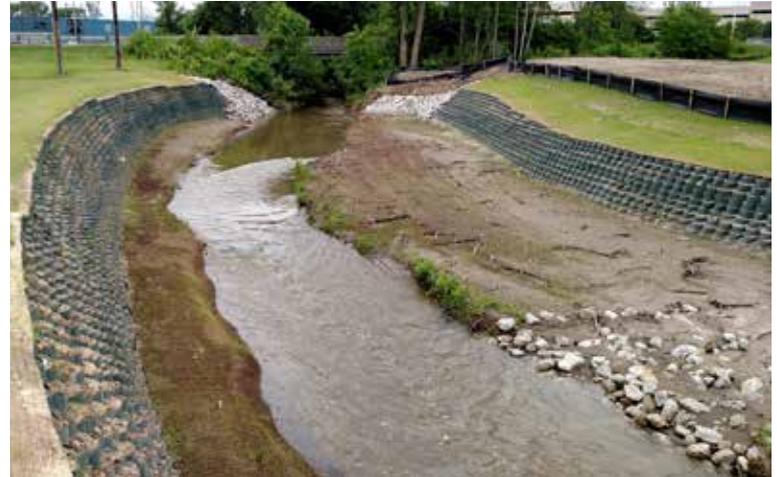
A two-stage channel for additional water storage incorporated GEOWEB vegetated channel for bank stabilization and protection to an area prone to flash flooding.

A 10-mile watercourse in Indiana was prone to flash flooding that reached streets within a business park. The banks of the creek were heavily overgrown and difficult to maintain, contributing to flash flooding. An analysis of the watershed helped to determine improvements in two phases.

Phase 1 included constructing three offline overflow ponds upstream of the business park. Phase 2 included constructing a two-stage channel for additional water storage and incorporated GEOWEB vegetated channel for bank stabilization and protection to the area prone to flash flooding. The GEOWEB solution was selected because it allowed for steep (0.5:1) slopes and would allow a small horizontal footprint for extra flood capacity.
