GEOWEB®

SITE ACCESS/MAINTENANCE ROAD Transmission Line Access Through Wetlands

Rebuilding Roads, Replacing Transmission Lines Damaged During Hurricane Michael in Florida's Panhandle.

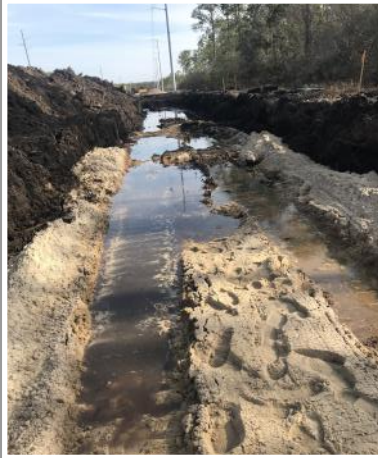
Wet, muddy ground through swamps and farmland prior to installation of new GEOWEB® stabilized road for transmission line access.

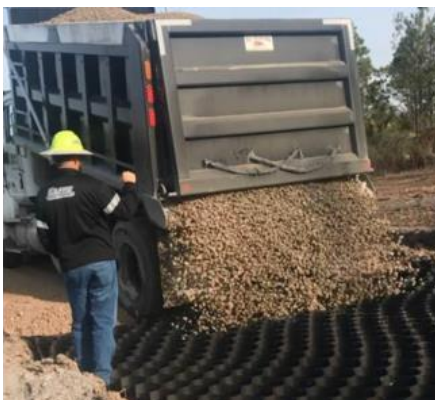
Delivering & Spreading GEOWEB Infill

Presto's **GEOWEB® 3D soil stabilization system** keeps aggregate fill contained for a stable driving surface. The system was fast to deploy and install with local crews. Weather-resistant, ATRA® Key connectors were used to join GEOWEB® panels.

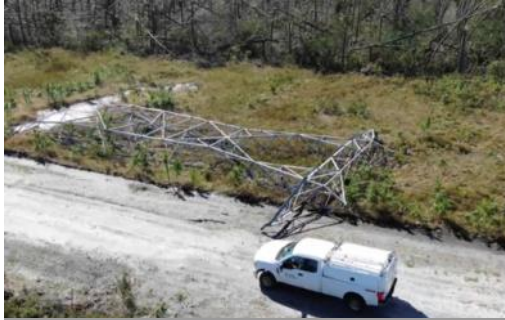
Downed Transmission Towers
Duke Energy Photo Credit

The downed towers were damaged beyond repair and would be replaced by stronger steel poles. Because of the remote location, extremely saturated ground and difficulty in accessing these lines, the towers, weighing 8,000 to 25,000 pounds, were set by a fleet of Black Hawk helicopters. Crews on the ground installed the towers which were transported in two to five parts and reassembled onsite.

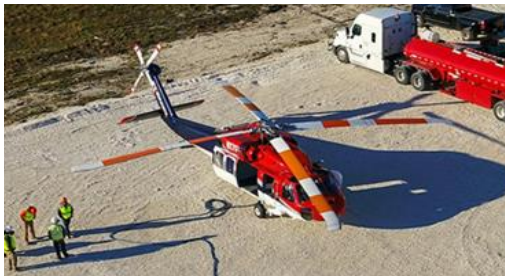
Black Hawk Helicopters Transport New Towers
Duke Energy Photo Credit

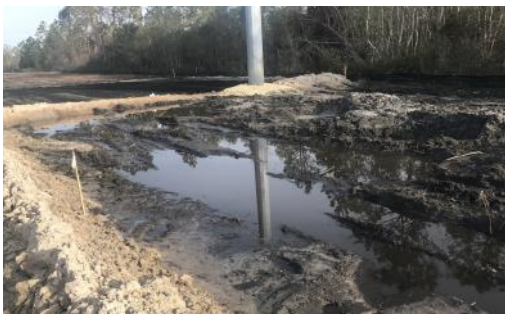
Wet Areas around Newly Placed Tower Poles

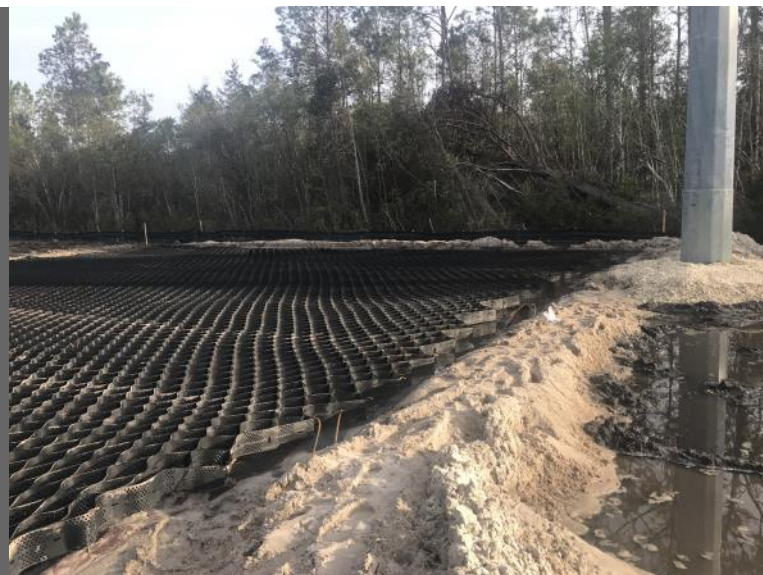
The GEOWEB® 3D system is placed over an enhanced geotextile and filled with crushed aggregate for access roads across critical wetlands areas and for stabilizing pole pads.

The roads and pads are permanent.
